ORIGIN AND DEVELOPMENT OF LEADING-EDGE CRACKS IN TURBOJET ENGINE BUCKETS

By D. F. Springsteen, C. A. Gyorgak,
and J. R. Johnston

Lewis Flight Propulsion Laboratory
Cleveland, Ohio

May 20, 1957
Declassified March 19, 1959

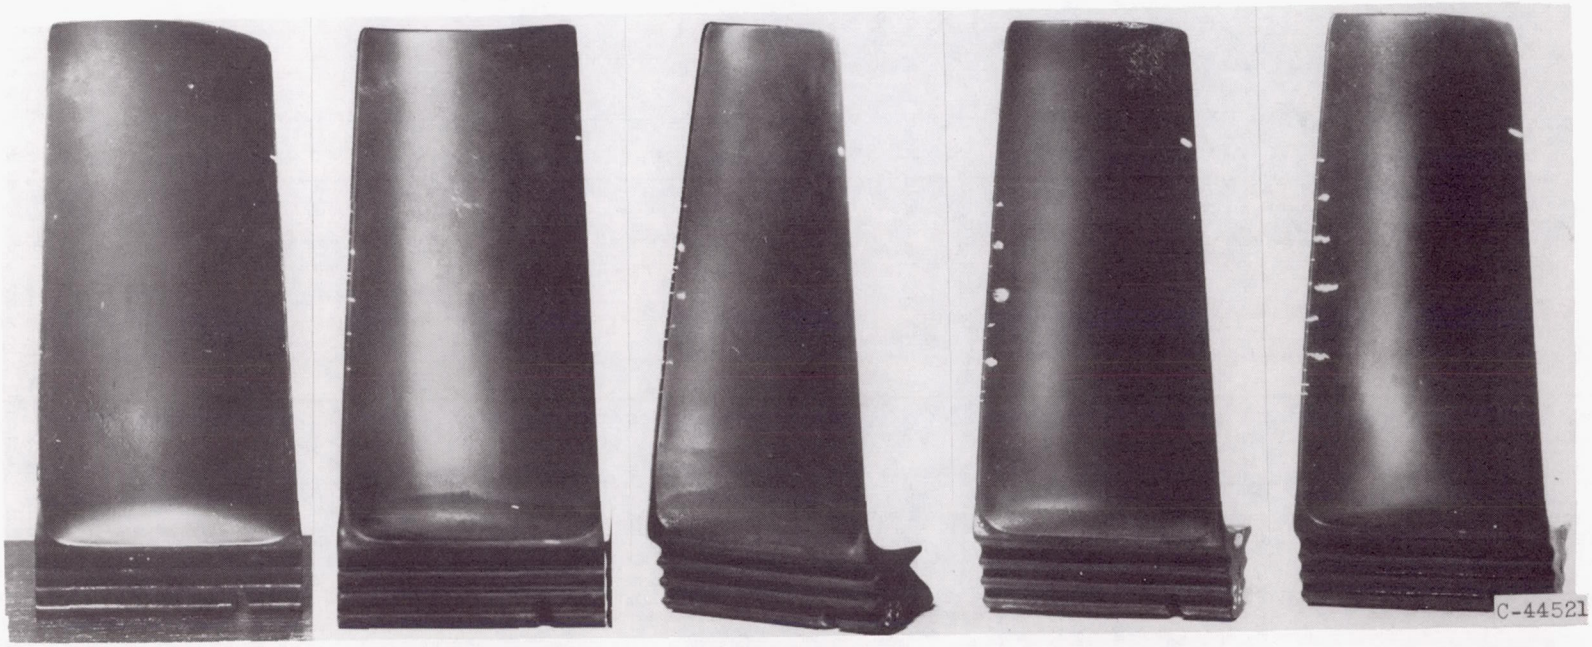
(a) Inconel 550.

Two different types of crack propagation that occur in buckets are shown in figure 4. In the bucket shown in figure 4(a)(Inconel 550), the cracks were first detected during the 55-hour inspection. The cracks propagated at a moderate rate for the next 200 hours but then slowed to such a slow rate that the bucket was still operating when the test was discontinued after 500 hours. In contrast to the bucket shown in figure 4(a) is the bucket in figure 4(b)(S-816 bucket). This bucket developed only a few cracks by 55 hours. However, two of these cracks grew very quickly, and within 120 hours one of these two cracks was nearly 1/2 inch deep. For the next 125 hours the cracks hardly grew, until finally at 306 hours the bucket fractured.

Figure 4. - Examples of crack propagation in turbine buckets.

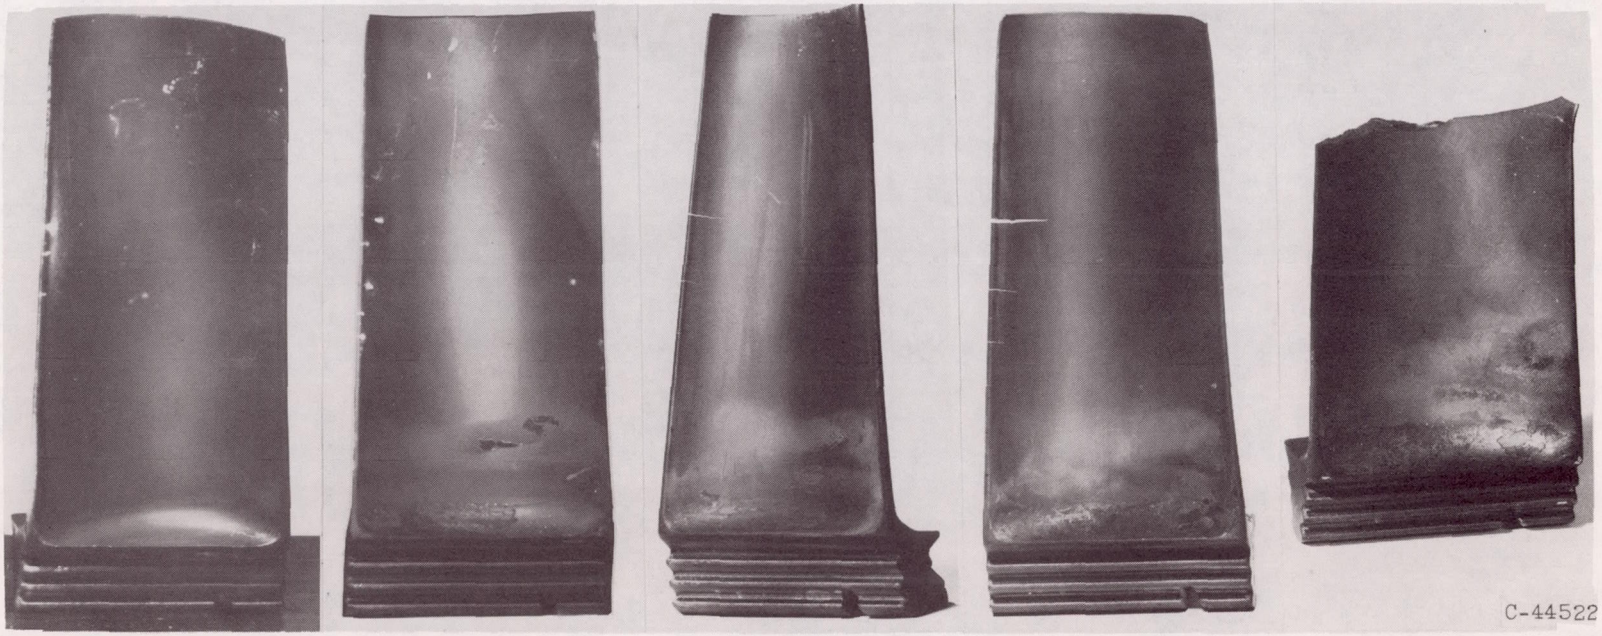
(b) S-816.

Figure 4. - Concluded. Examples of crack propagation in turbine bucket.

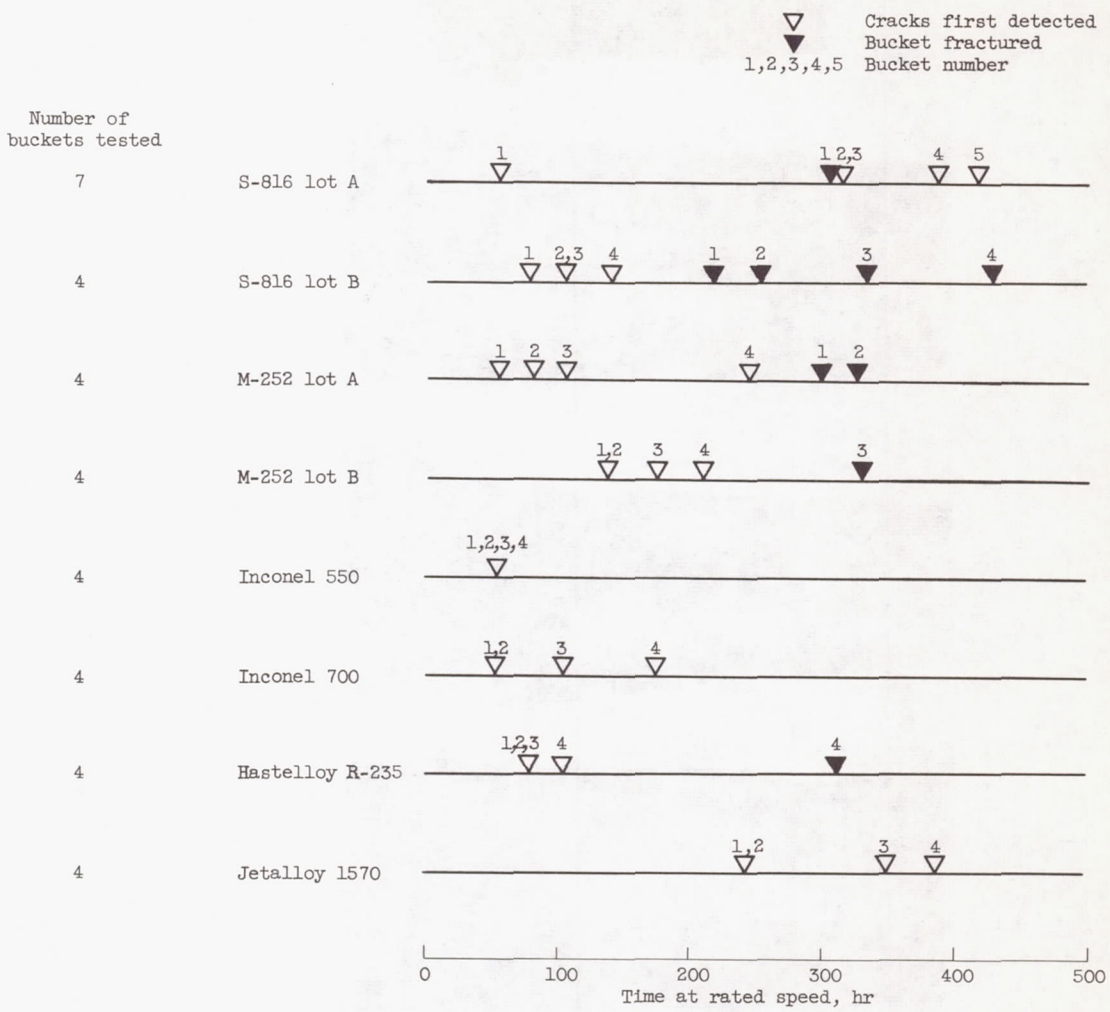
Performance of as-received buckets. - All the lots of as-received materials developed cracks before 245 hours of operation at rated speed as shown in figure 5. In three of these materials, M-252 lot A, Inconel 550, and Inconel 700, cracks were detected as early as 55 hours. The two materials that displayed the best resistance to cracking were Jetalloy 1570 and S-816 lot A. Cracks were first noted in Jetalloy 1570 at 245 hours. Although one of the S-816 lot A buckets showed cracks at 55 hours, this short time to cracking was so far outside the scatter band for the material that it could not be considered a representative bucket. For the remainder of the buckets of the S-816 lot A group no cracks were observed until 312 hours of engine operation.

Figure 5. - Comparison of performance of as-received bucket materials. Test discontinued at 500 hours.

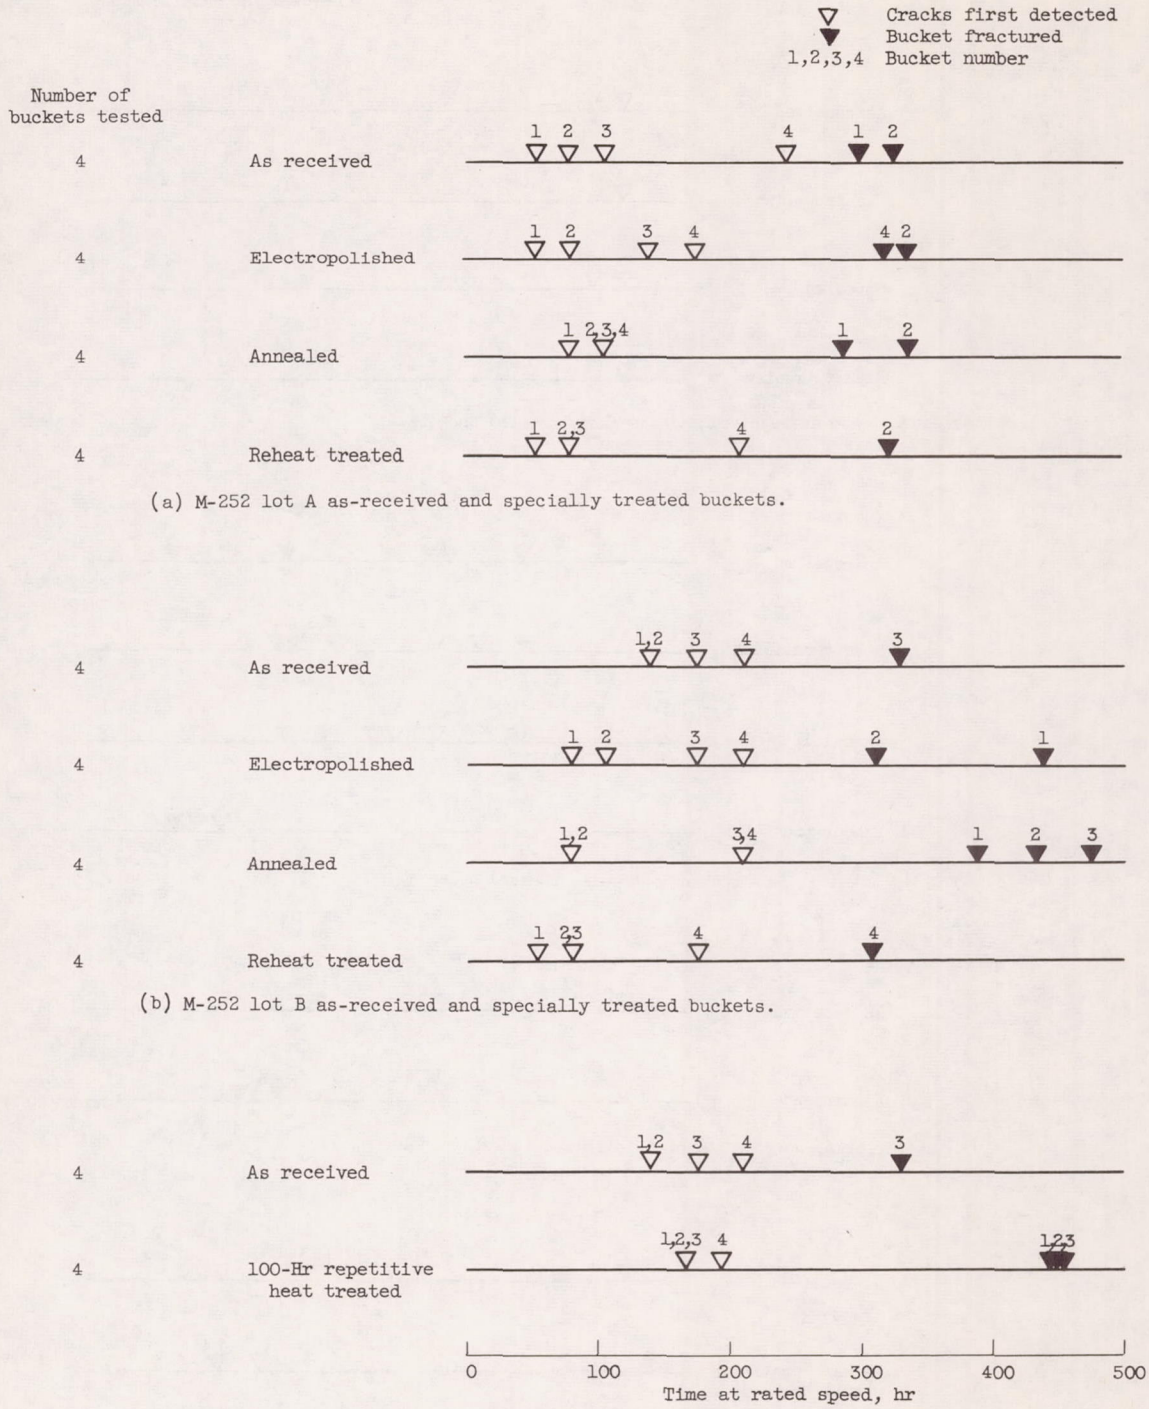
Performance of specially treated M-252 buckets. - The crack resistance and service-life performances for all the groups of both M-252 lot A and M-252 lot B were very similar (figs. 6(a) and (b)). When compared on the basis of average time to cracking, all the groups (as-received, electropolished, annealed, and reheat-treated) for both materials cracked at about the same time, approximately 125 hours.

cracks about the same time as the untreated buckets (approximately 175 hr), as shown in figure 6(c). At 500 hours, three of the repetitive reheat-treated buckets had fractured as compared with only one fractured as-received bucket. Since the repetitively heat-treated buckets cracked before the second scheduled heat treatment, they received only one reheat treatment.

(a) M-252 lot A as-received and specially treated buckets.

(b) M-252 lot B as-received and specially treated buckets.

(c) M-252 lot B as-received and 100-hour, repetitively heat-treated buckets.

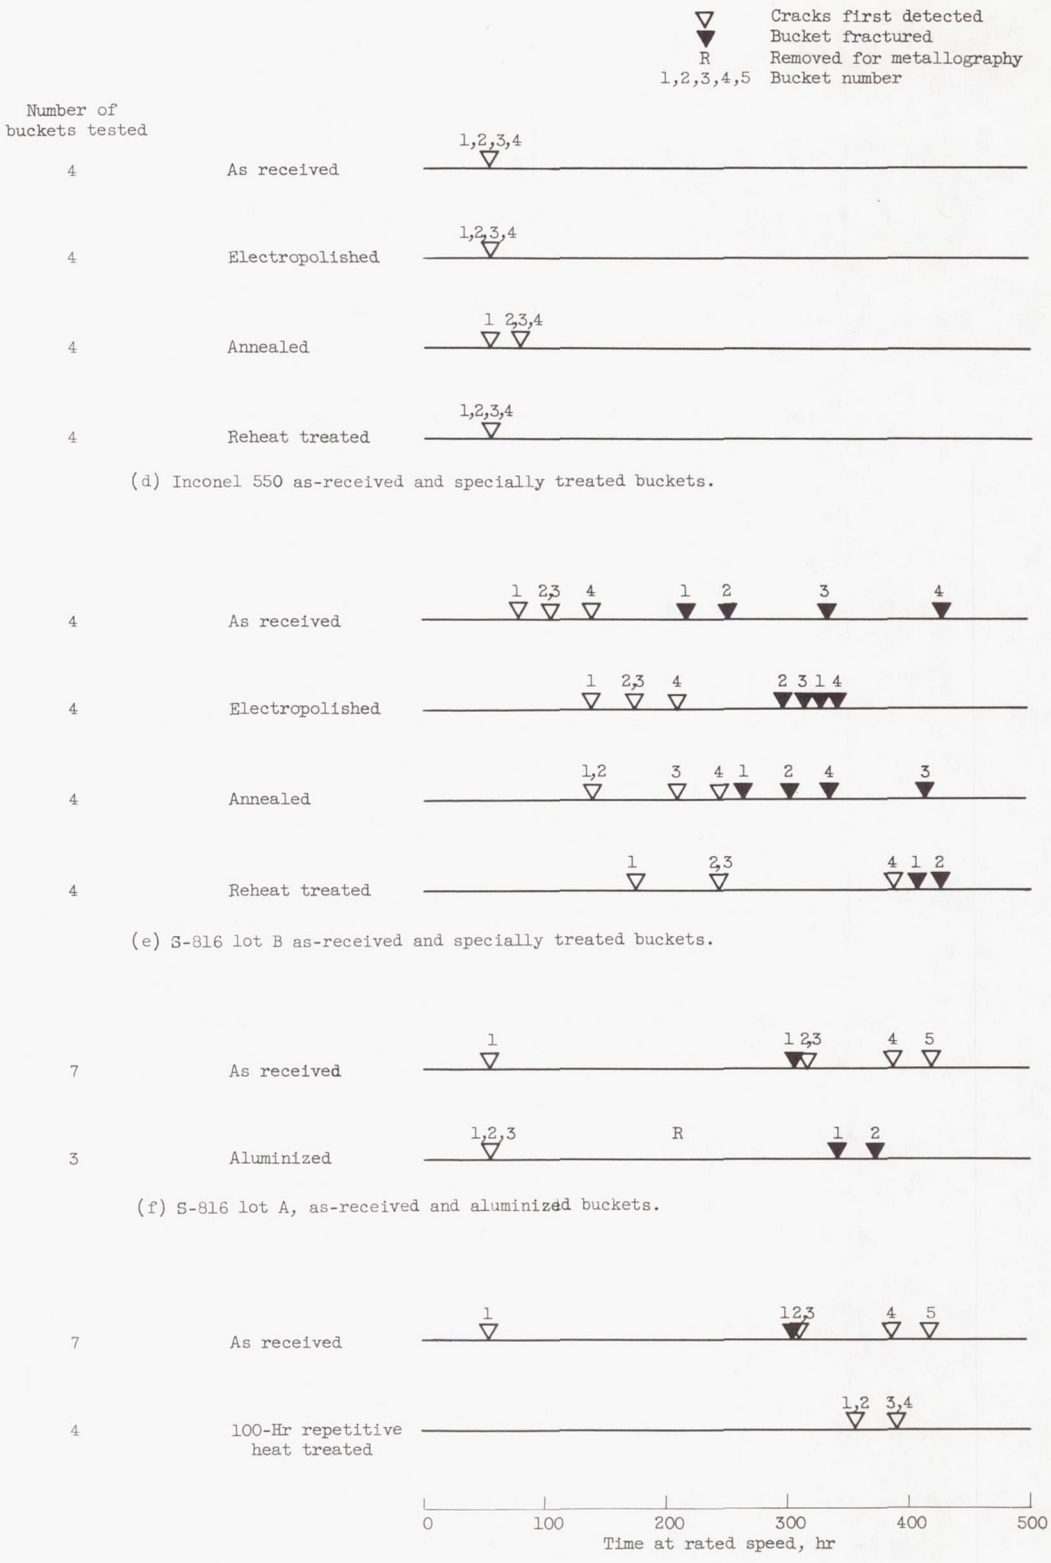
Performance of specially treated Inconel 550 buckets. - All the groups of the specially treated and as-received Inconel 550 buckets had cracks at 55 hours as shown in figure 6(d). None of the groups had fractured buckets when the test was discontinued after 500 hours of operation.

Figure 6. - Turbine bucket performance. Test discontinued at 500 hours.

(d) Inconel 550 as-received and specially treated buckets.

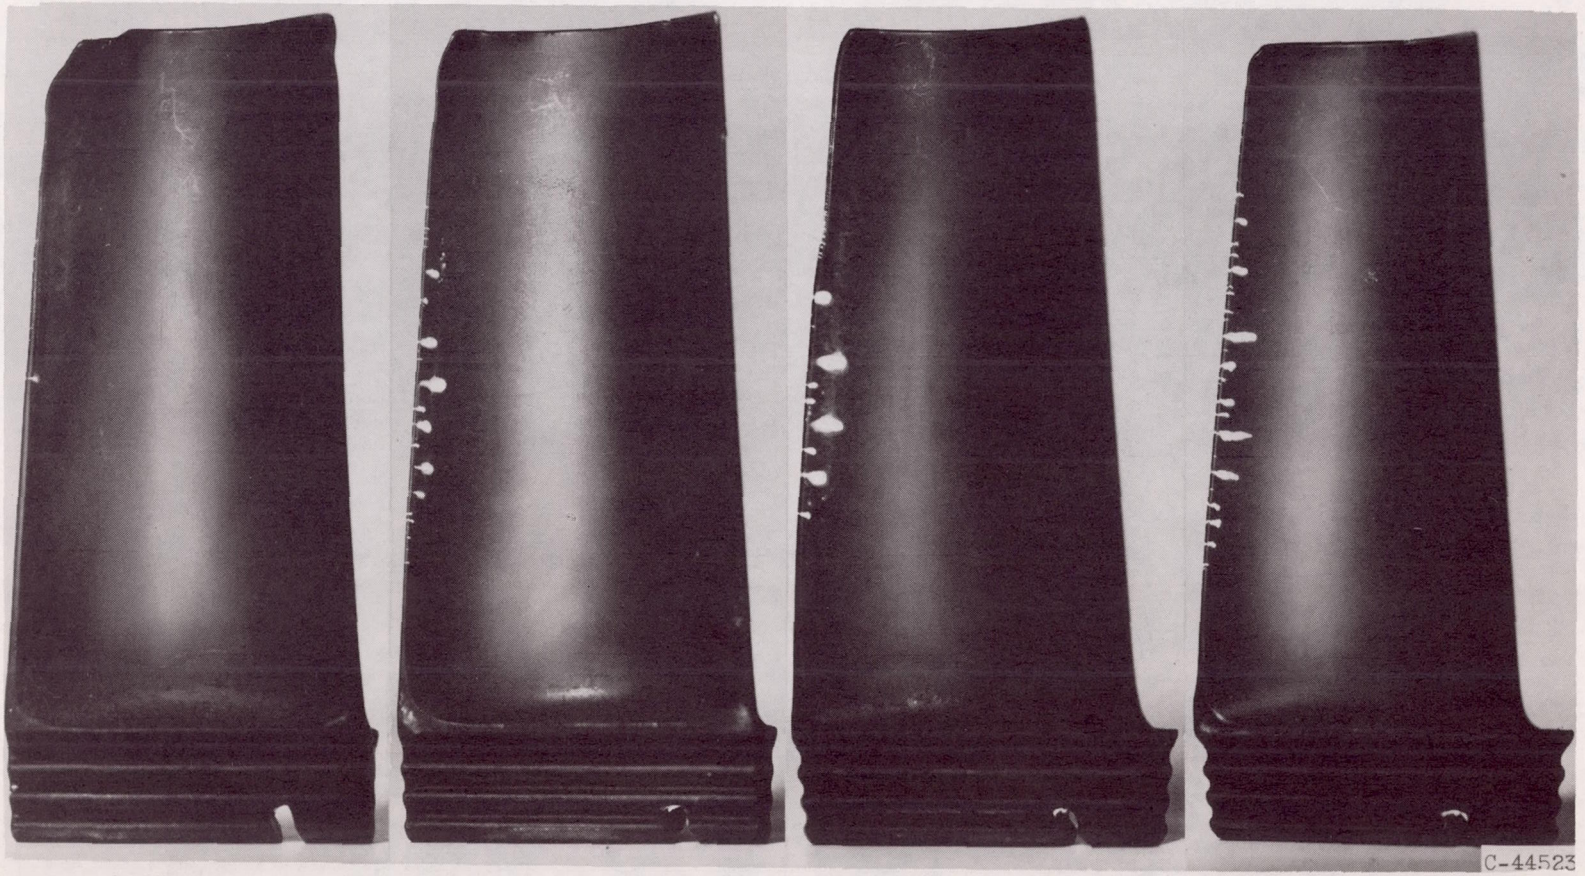
Fifty-nine of the buckets ran the full 500 hours without fracturing. Fifty-seven of these buckets had leading-edge cracks. (Two S-816 lot A buckets did not have cracks.) Figure 7 is a set of photographs taken after 500 hours of operation showing seven typical unfractured buckets with leading-edge cracks. Each bucket is a different as-received material. These photographs in figure 7 were taken with an ultraviolet light after the buckets were given a Zyglo treatment. During the $1\frac{1}{2}$ hour exposure time, the Zyglo oil bled from the cracks, producing the blotchy effect seen in the photographs.

Figure 7. - Typical buckets that operated 500 hours at full power without fracturing. (Note leading-edge cracks.)

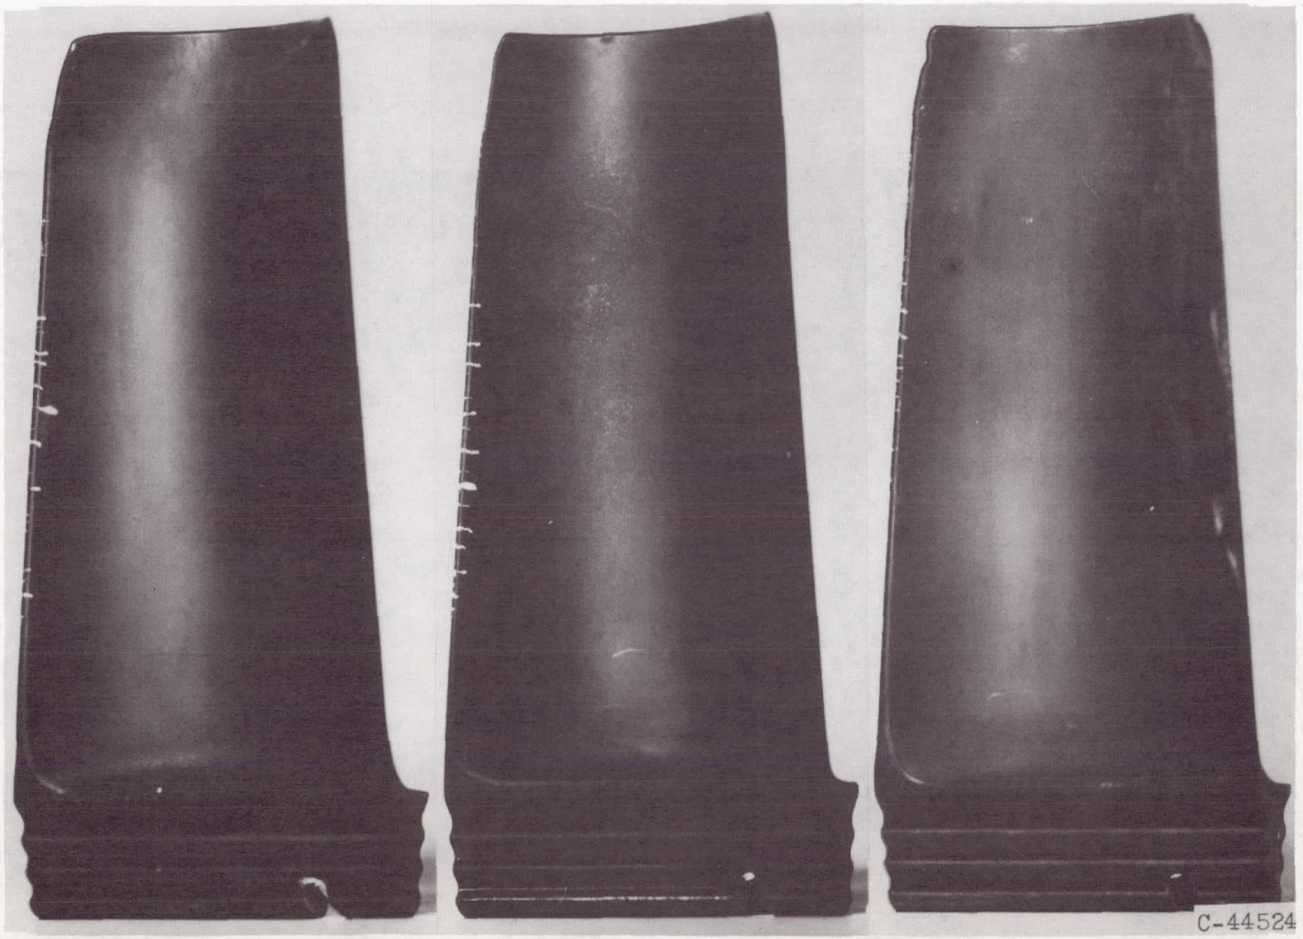
Figure 7. - Concluded. Typical buckets that operated 500 hours at full power without fracturing. (Note leading-edge cracks.)

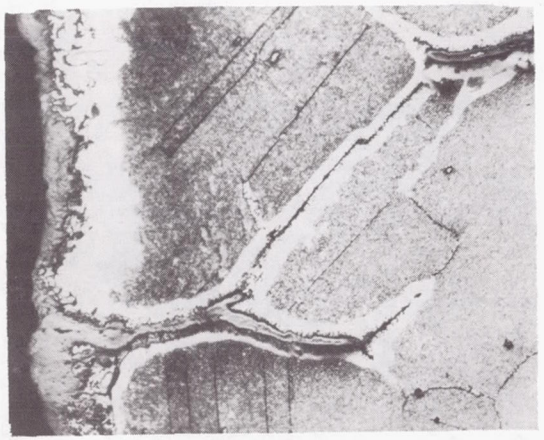
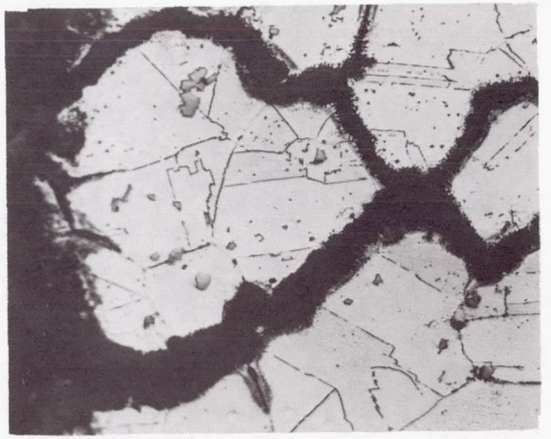
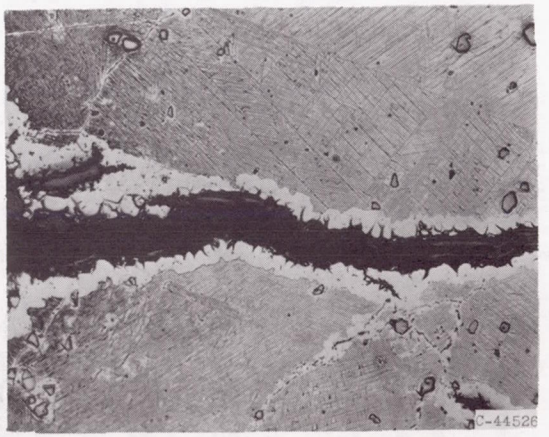
Microexaminations were performed on the leading-edge regions of the 29 buckets enumerated in table V to determine the nature of the leading-edge cracks. In almost every instance, the cracks appeared to be intergranular. Figure 8 shows photomicrographs of typical leading-edge cracks as they occurred in the unfractured buckets shown in figure 7. In all these photographs, the surrounding structures appear normal for the material.

Figure 8. - Microphotographs of leading-edge cracks in buckets operated 500 hours without fracture. Eight different lots of material. X400.

Figure 8. - Concluded. Microphotographs of leading-edge cracks in buckets operated 500 hours without fracture. Eight different lots of material. X400.

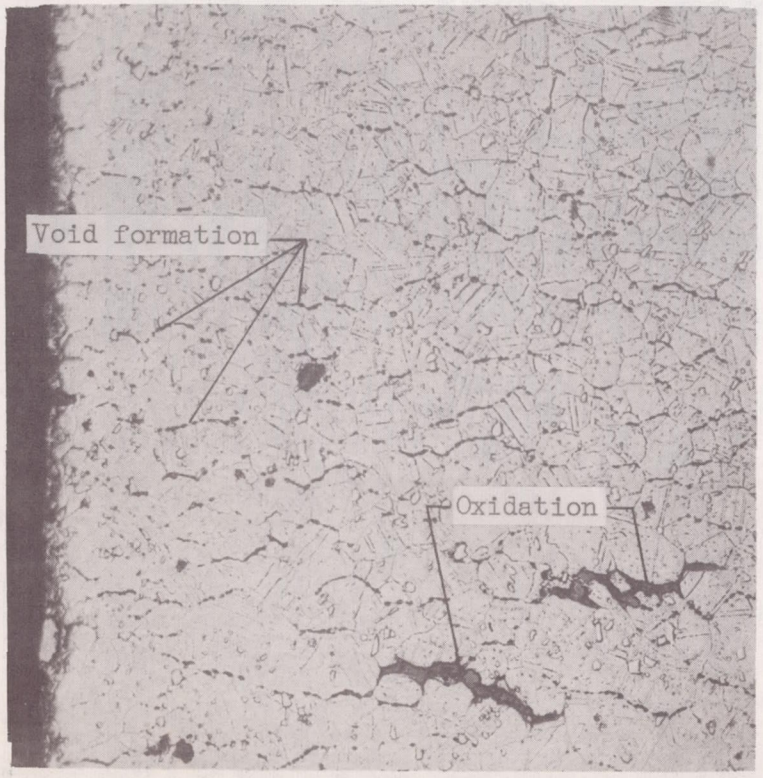
Of all the buckets examined, the only bucket with the slightest indication of abnormal structure was an S-816 lot B bucket (fig. 9). The small dark areas in the grain boundaries may have been caused by vacancy migrations. Some of the cracks that ultimately developed in the area were lined with oxides.

Figure 9. - Oxidation and void formation in grain boundaries of S-816 lot B bucket. X250.

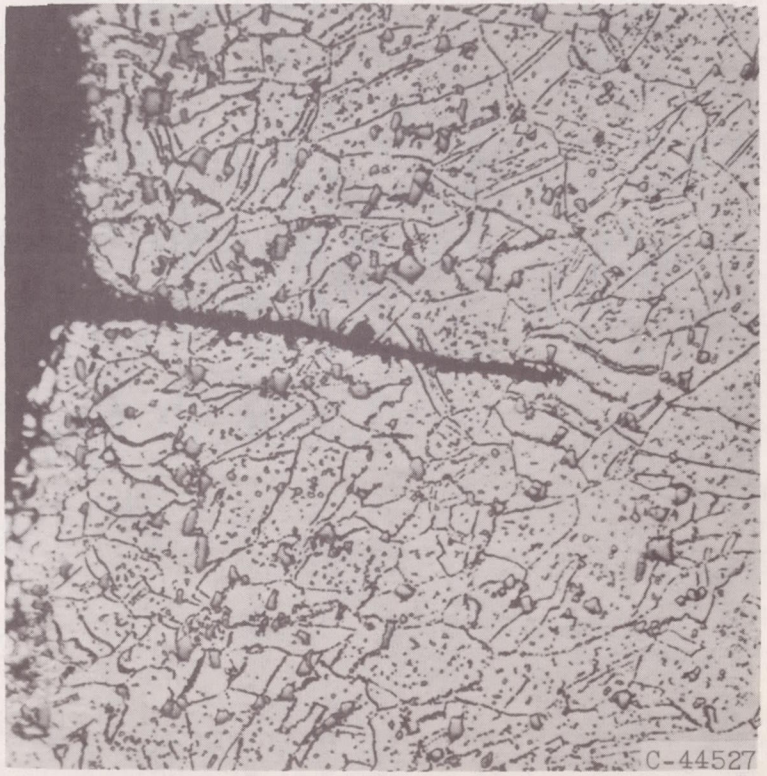
Figure 10 is a photograph of a leading-edge crack in an S-816 lot B bucket, which appears to be transgranular. This particular crack was the only definite transgranular leading-edge crack found during the microexaminations.

Figure 10. - Transgranular leading-edge crack in S-816 lot B bucket. X400.

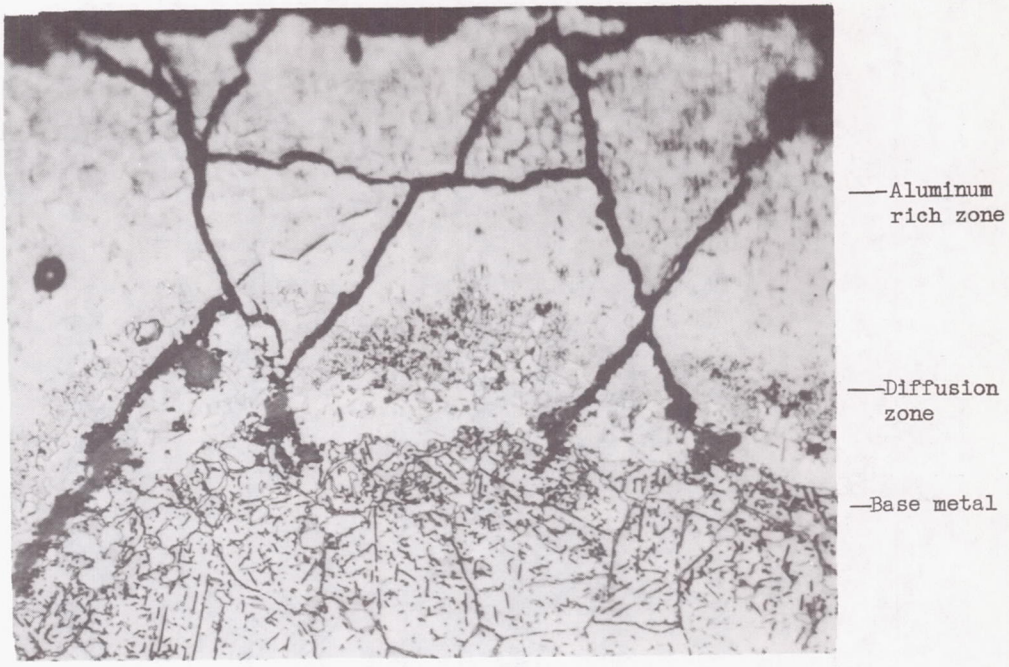
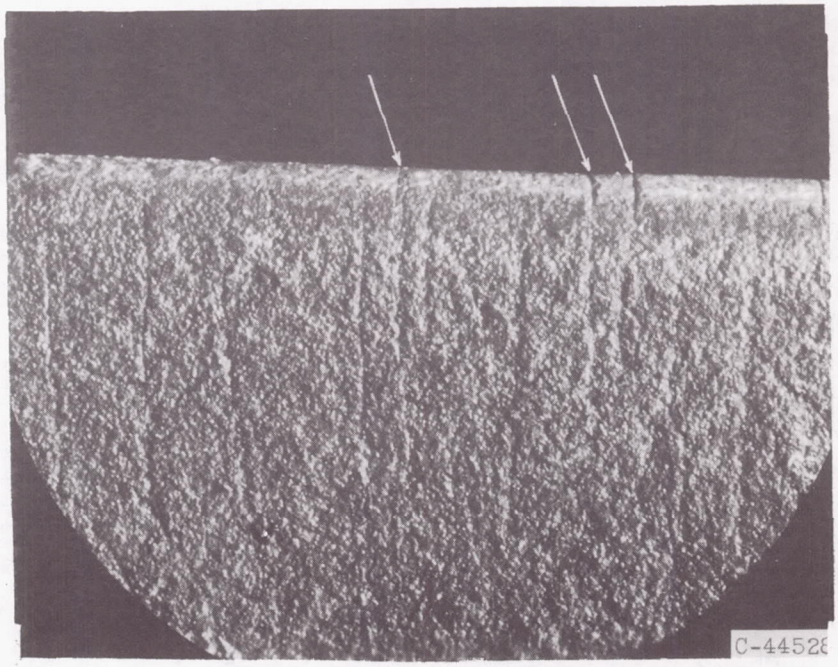
One of the aluminized S-816 buckets was removed from the wheel before it fractured (after 244 hr of operation), and a section was taken of the leading edge to determine whether the cracks penetrated beyond the aluminum coating. Figure 11(a) is a photomicrograph of the leading-edge region shown in figure 11(b). The photomicrograph shows diffusion has taken place between the aluminum coating and the base metal. The cracks did not extend beyond the diffusion zone (fig. 11(a)).

Figure 11. - Leading-edge cracks in aluminized S-816 lot A bucket. Operation time, 244 hours.

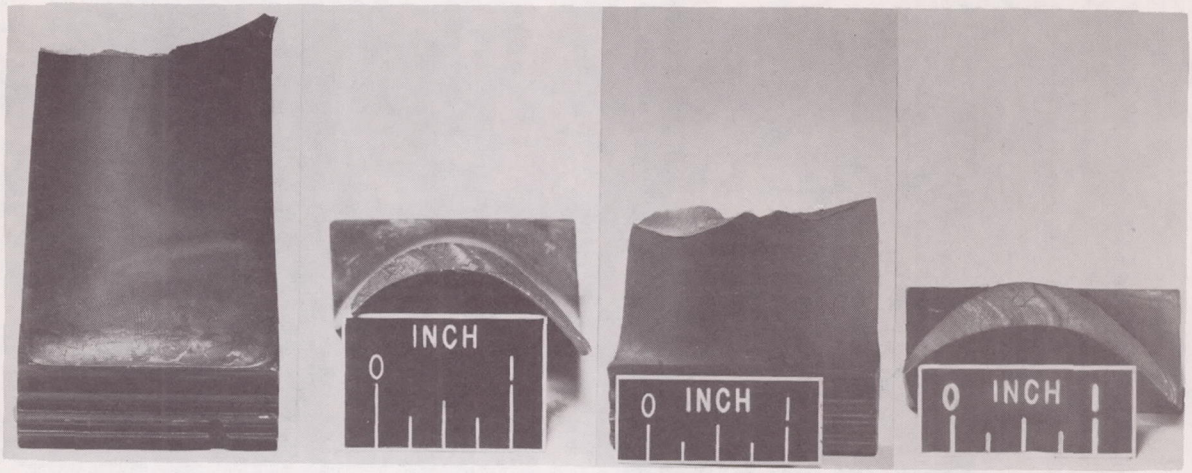
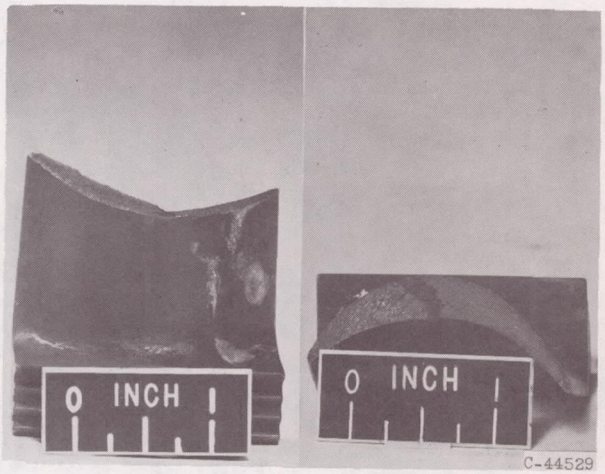
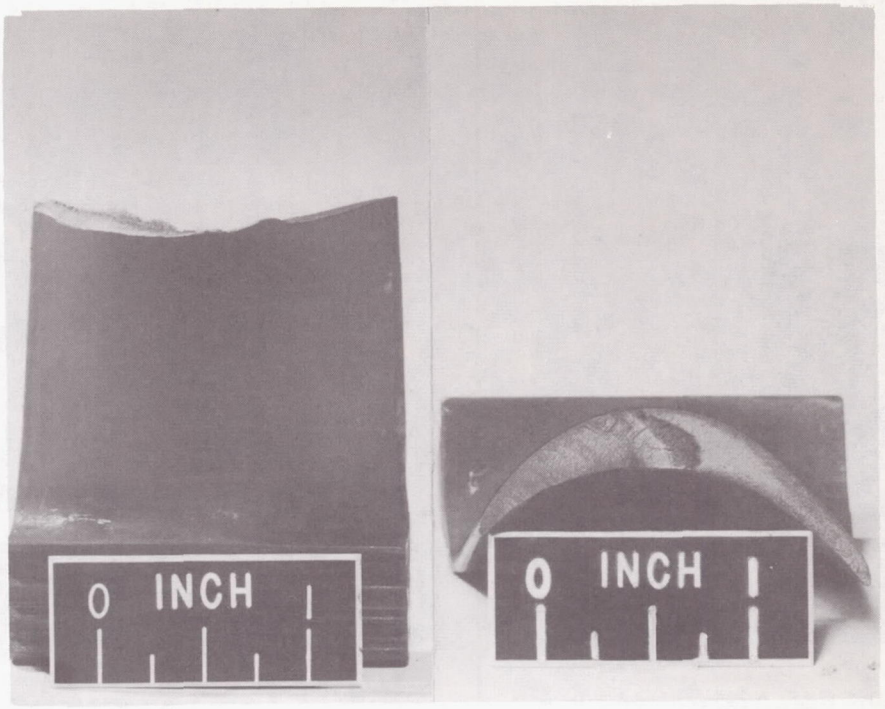
All the buckets that fractured were visually examined to locate the origin of the fracture. The examinations disclosed that all the fractures began at the leading edges of the buckets. The zone where the fracture began always had the rough appearance of an intergranular stress-rupture-type failure. The zone adjacent to the fracture origin

Figure 12 shows the photographs of typical fractured untreated (as-received) buckets of S-816 (fig. 12(a) and (b)), M-252 (fig. 12(c) and (d)), and Hastelloy R-235 (fig. 12(e)). None of the other materials tested incurred fractures during the test.

(a) S-816 lot A as-received bucket. Fractured, 306 hours.

(b) S-816 lot B as-received bucket. Fractured, 335 hours.

(c) M-252 lot A as-received bucket. Fractured, 300 hours.

Figure 12. - Typical bucket fractures resulting from engine operation.

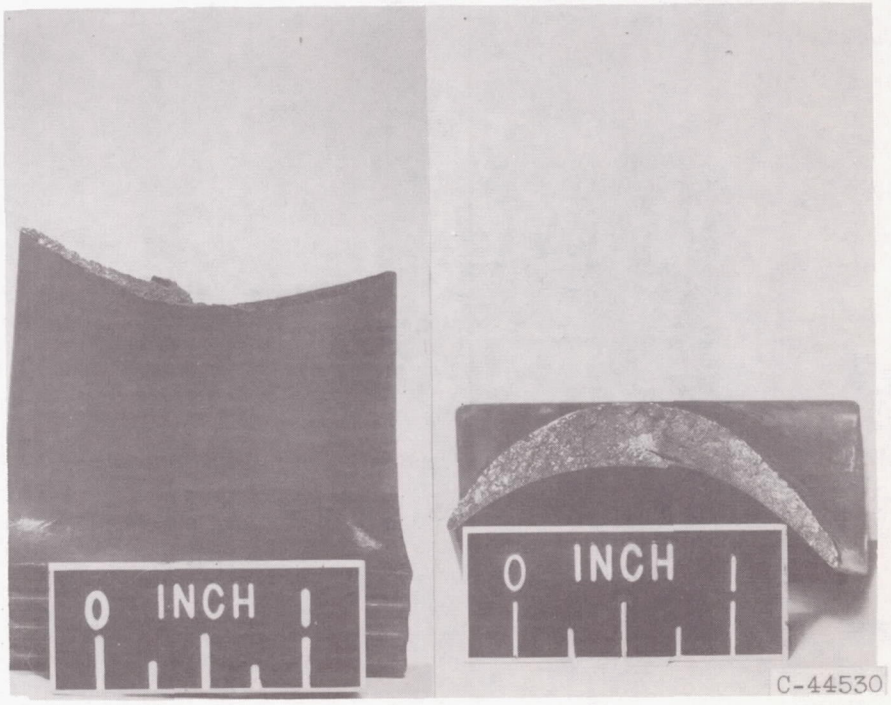
(d) M-252 lot B as-received bucket. Fractured, 330 hours.

(e) Hastelloy R-235 as-received bucket. Fractured, 312 hours.

Figure 12. - Concluded. Typical bucket fractures resulting from engine operation.

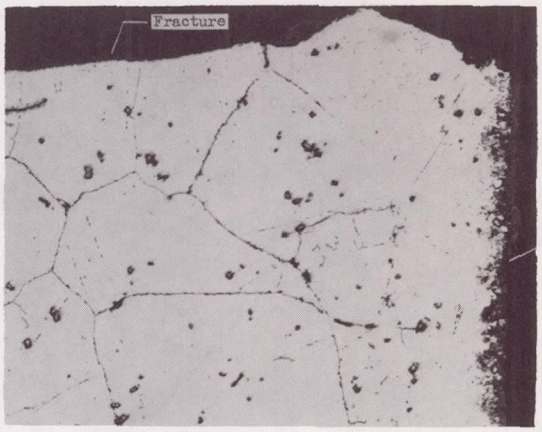
Figure 13. - Fracture origin in leading edge, Hastelloy R-235. Fractured, 312 hours.

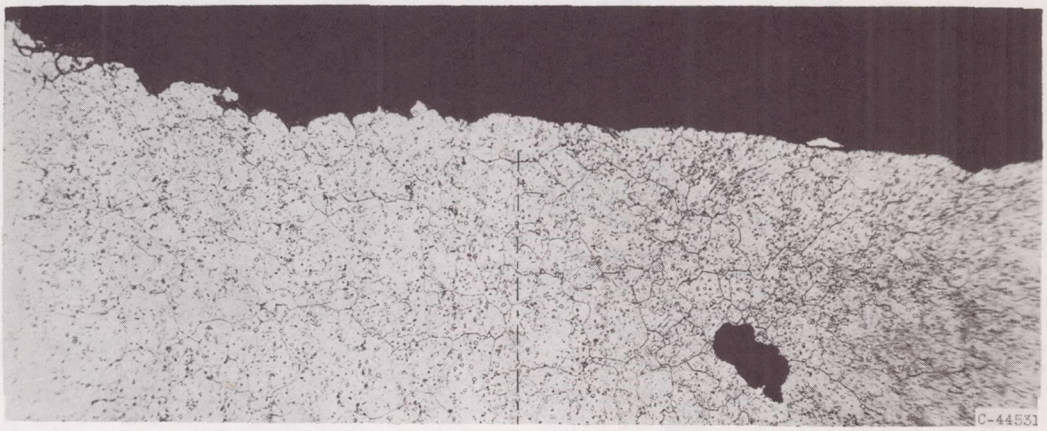
Microsections of 17 of the 35 fractured buckets were taken from the regions where the fractures occurred. Usually the region very close to the leading edge of the buckets appeared so oxidized that it was difficult to determine whether the fracture began as a transgranular or intergranular failure. In a few buckets, the region was not too badly damaged by oxidation, and the fracture origin appeared to be intergranular in nature. Figure 13 is a photomicrograph of the region where the fracture began in a Hastelloy R-235 bucket. The intergranular cracks in this Hastelloy R-235 bucket soon changed to transgranular and propagated as a transgranular crack for about 1/2 inch. Another example of a fracture changing from intergranular to transgranular, this time in an M-252 bucket, is shown in figure 14.

Figure 14. - Transition from intergranular to transgranular fracture for M-252.
